Manhole Inspection Summary

Manhole # S11S__006MH

Insp Date: **3/28/08 10:06 AM**

Location Address: **903 Desoto DR**

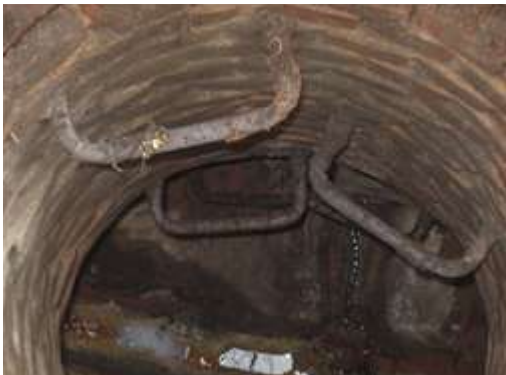
Defect 7

Steps Count: **5** Missing: **0** ☒ **Corroded**

rusted rungs

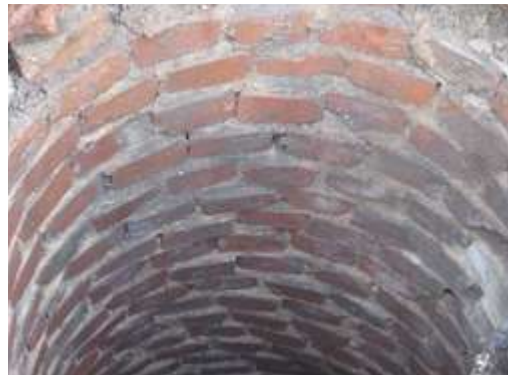
Defect 6

corbel-missing mortar

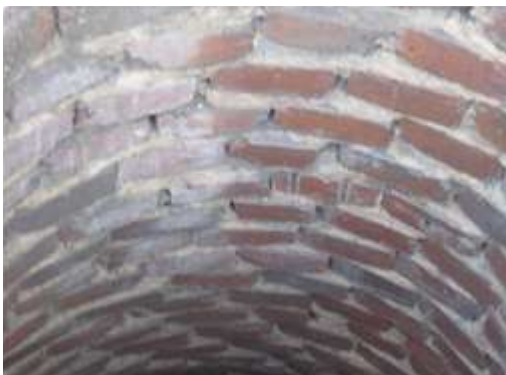
Defect 5

missing mortar

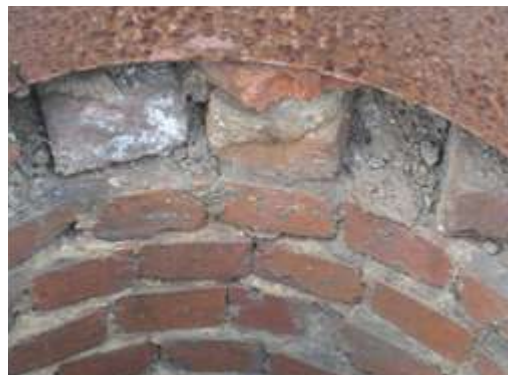
Defect 4

loose bricks

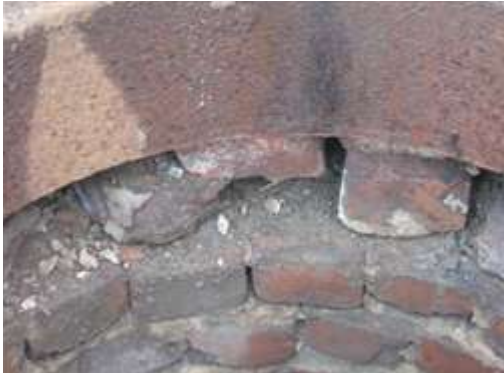
Defect 3

loose bricks

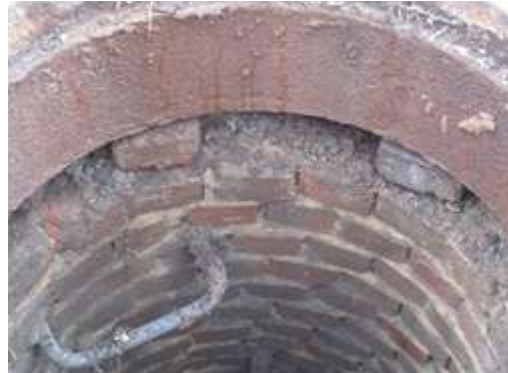
Defect 2

Condition: ☐ Sound ☐ Cracked ☐ Root Intrusion ☒ **Loose Brick** ☒ **Deteriorated**

Infiltration: ☐ None ☐ Joint ☐ Cracks ☒ **Mortar** ☐ Roots ☐ Wall

missing mortar and bricks/Infiltration in the chimney

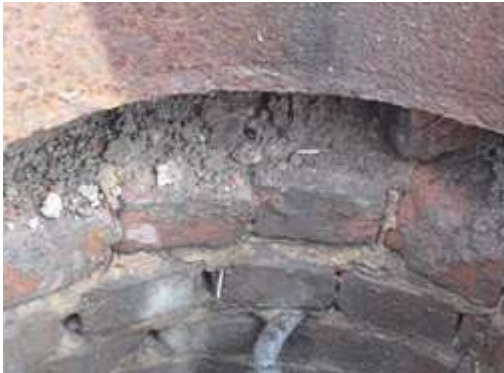
Defect 1

Frame Offset: **0** (in.) Condition: ☐ Sound ☐ Cracked ☒ **Leaks**

frame leaks, missing bricks

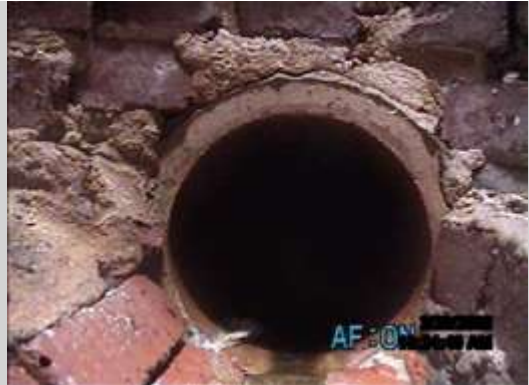
12 O'Clock Outflow

Pipe Height: **8.4** (in.) Rod and Bar (Angled)
Pipe Material: **Clay** ☐ Pipe Lined
Invert Depth: **9.60** (ft.) Flow Characteristics: **Slow**
Deposits: ☒ None ☐ Mud ☐ Sludge ☐ Debris ☐ Grease
Silt Depth: **0** (in.) Deposits Extent:
Infiltration: **Evidence** Pipe Seal Cond: **Unknown**

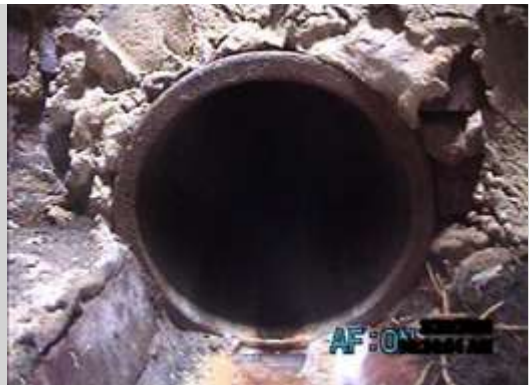
6 O'Clock Inflow

Pipe Height: **8.4** (in.) Rod and Bar (Angled)
Pipe Material: **Clay** ☐ Pipe Lined
Invert Depth: **9.50** (ft.) Flow Characteristics: **Slow**
Deposits: ☒ None ☐ Mud ☐ Sludge ☐ Debris ☐ Grease
Silt Depth: **0** (in.) Deposits Extent:
Infiltration: **Evidence** Pipe Seal Cond: **Unknown**

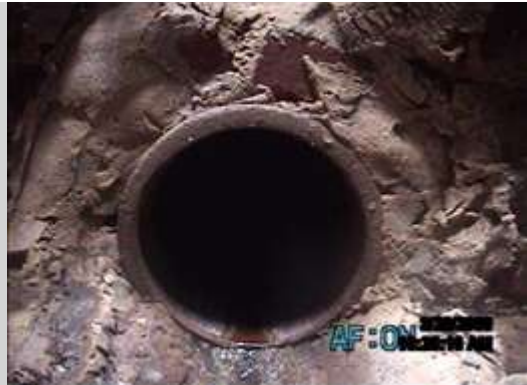
9 O'Clock Inflow

Infiltration: **Evidence**
